# Asphalt Pavement Crack Repair-SR 191, MM 15 +/- Using Deery Level & Go Mastic

## Final Report

**Experimental Feature X(05)14 – New Products**

Utah Department of Transportation  
Research Division

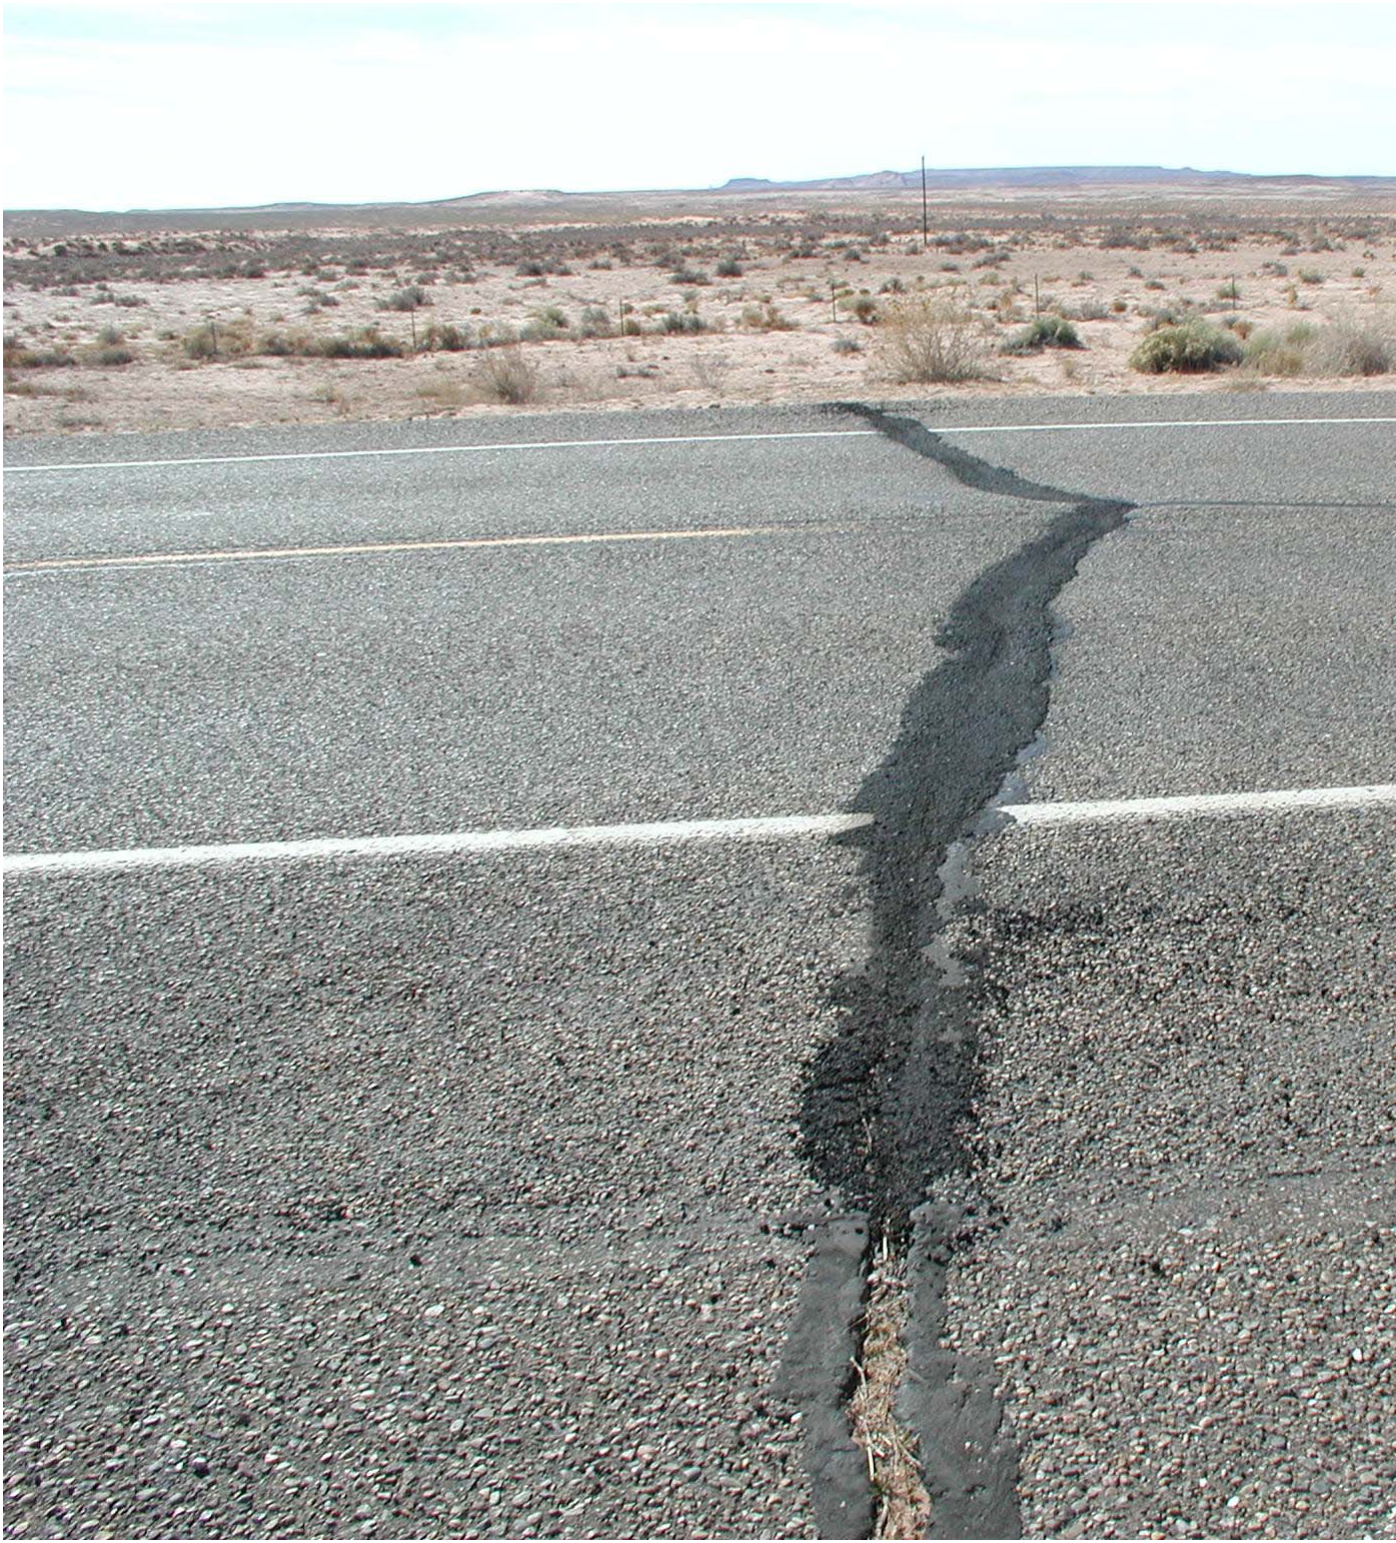
Review the installation process and determine how effective the Deery mastic was in repairing the wide transverse cracks. A visual evaluation was performed by Utah Department of Transportation, Research Division, was performed the second week of May 2006 and the product was doing quite well and will be considered at a viable process as regards asphalt crack repair, both longitudinal and transverse and potholes.

The product has performed quite well and will be considered as a viable process as regards asphalt crack repair, both longitudinal and transverse and potholes.
